DROP TESTING FOR HIGH RELIABILITY APPLICATIONS

P. Snugovsky, J. Bragg (jbragg@celestica.com), M. Romansky
Celestica International Inc.

Project Overview

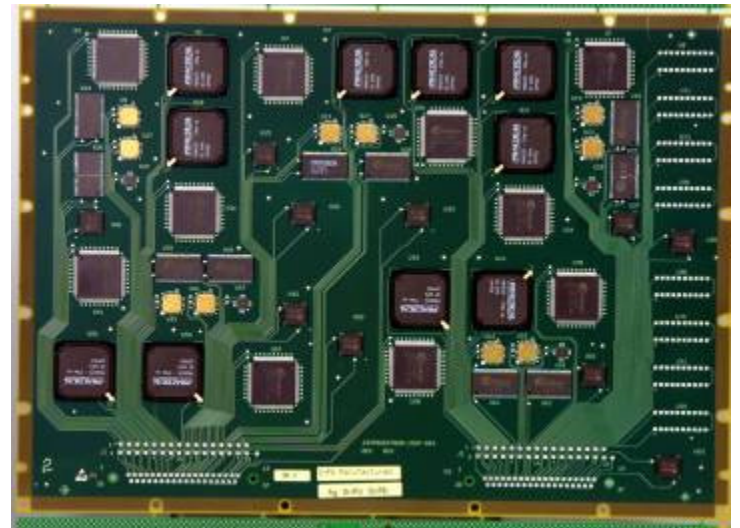
Test Vehicle Components

- Test vehicle designed by:
 - Joint Group on Pollution Prevention (JG-PP)
 - National Aerospace Agency (NASA)
 - Department of Defense (DoD)
- Designed to meet IPC-6012, Class 3 requirements
 - 6 layer board with 0.5-ounce copper
 - Pb-free FR4 laminate as per IPC-4101/26
 - Minimum Tg of 170°C
 - Immersion Ag finish

Package	Ball or Finish	Dimensions (mm x mm)	Pitch (mm)
PBGA225	SAC405 or SnPb	27 x 27	1.5
CSP100	SAC 105	10 x 10	0.8
TQFP-144	Matte Sn	20 x 20	0.5
TSOP-50	Sn	10 x 20	0.8
	SnBi	10 x 20	0.8
PDIP-20	NiPdAu	7.5 x 26	2.5
	Sn	7.5 x 26	2.5
CLCC-20	SAC305	9 x 9	0.8
QFN	Matte Sn	5 x 5	0.6

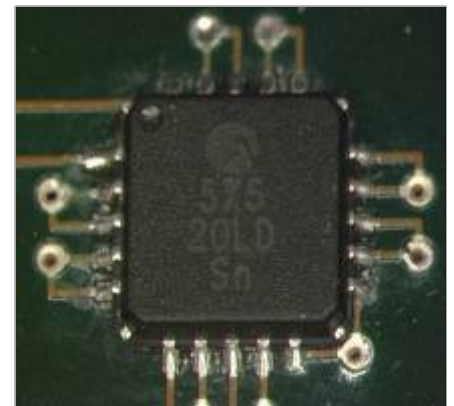
QFN

- Conductive: solder iron based rework on:
 - TSOP
 - TQFP
 - CLCC (tack wrap procedure)
- Conductive processes as per IPC-7711:
 - Solder wicking & vacuum extraction
 - Heat, lift part, pad cleaning
 - Part placement & fluxing
 - Drag solder replacement & cleaning
- Convective: hot air (N_2) rework for QFN, CSP and BGA devices

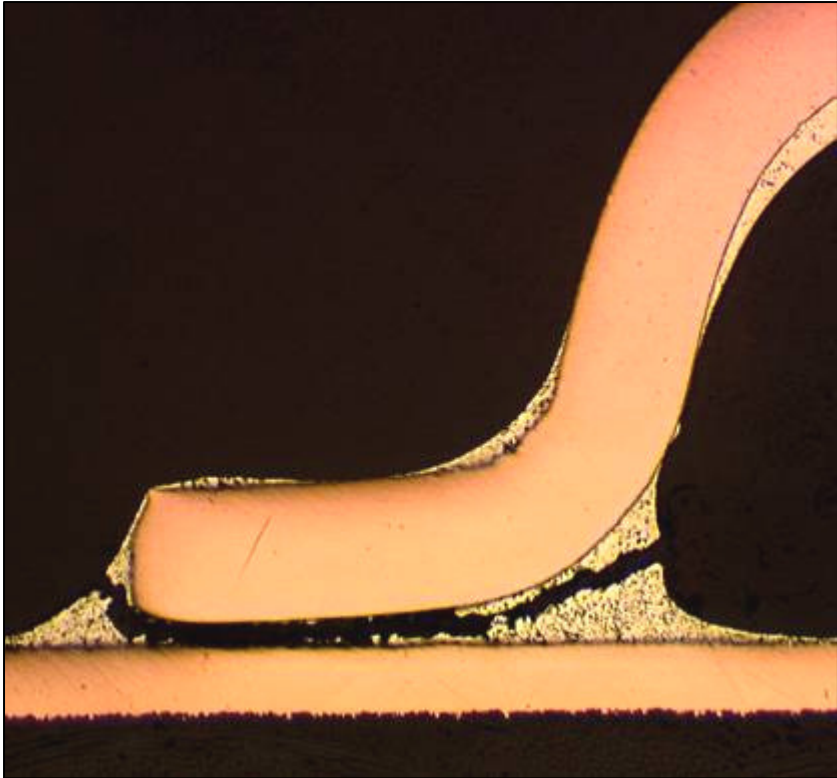
Solder Fracture
(TQFP-144)
